Debris/Ice/TPS Assessment and Integrated Photographic Analysis of Shuttle Mission STS-79

**DEBRIS/ICE/TPS ASSESSMENT
AND
INTEGRATED PHOTOGRAPHIC ANALYSIS
OF
SHUTTLE MISSION STS-79**

16 September 1996

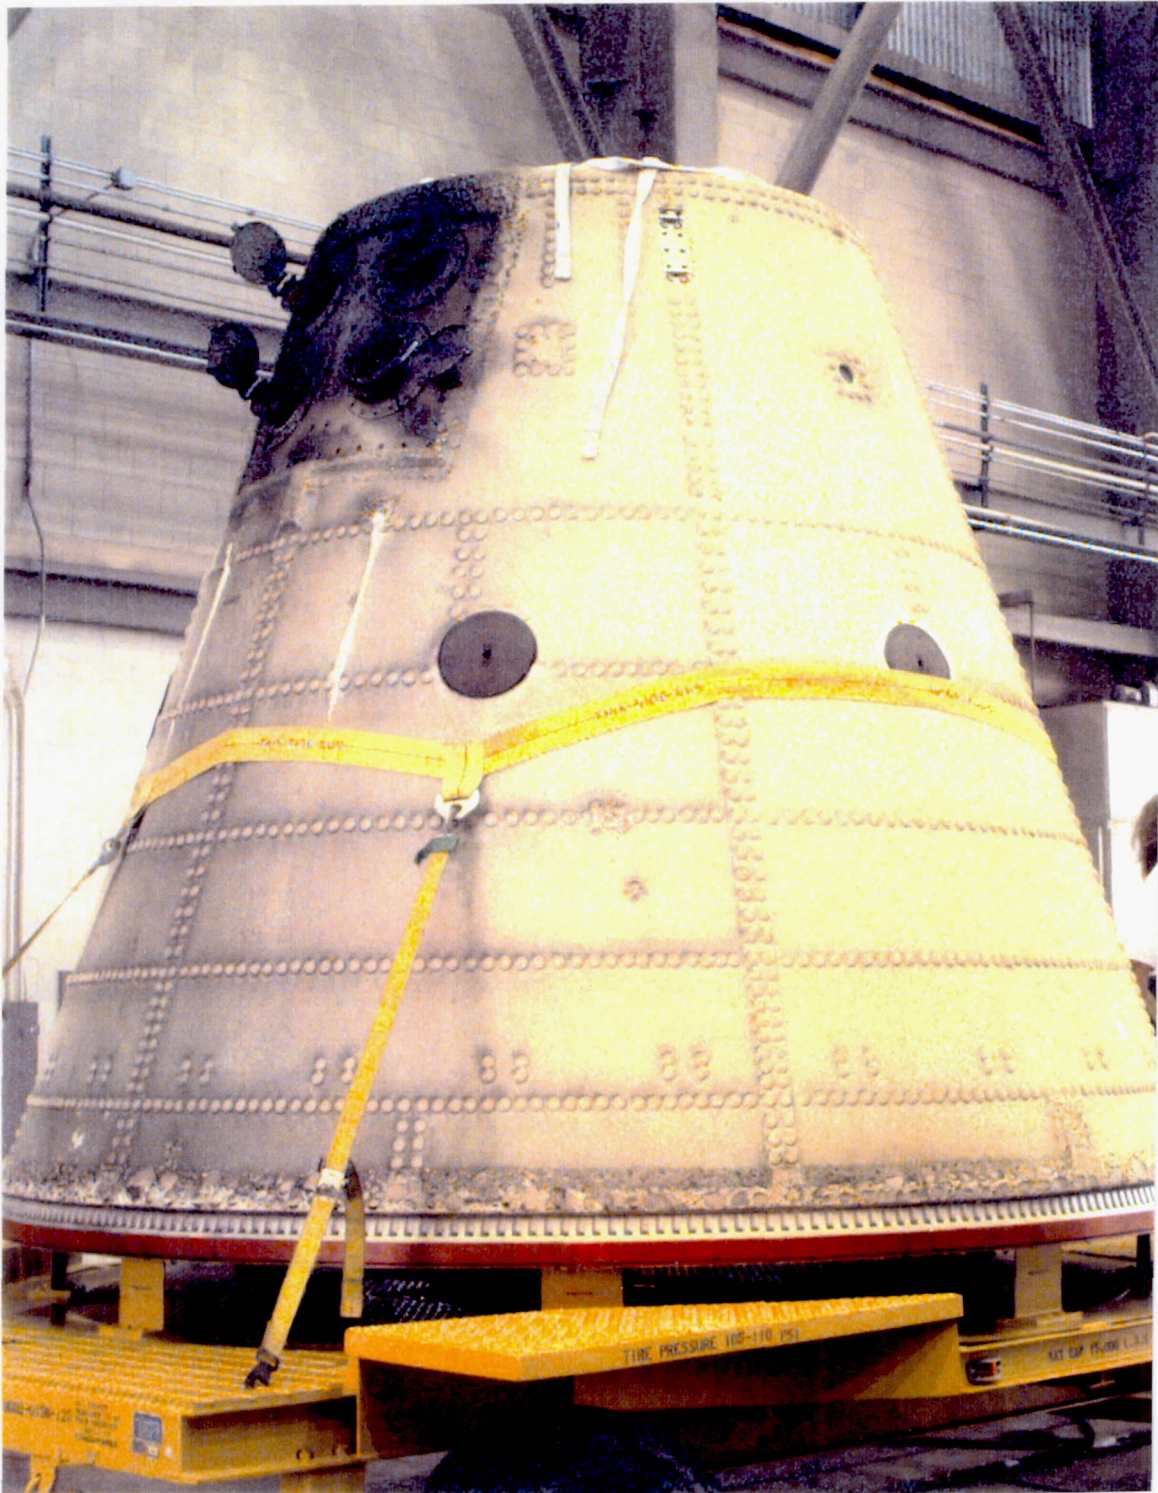
Photo 16: LH Frustum

The LH frustum was missing no TPS. The number of MSA-2 debonds over fasteners (5) was less than average (Figure 2). Hypalon paint was blistered/missing along the XB-395 ring frame where BTA closeouts had been applied. However, most of the exposed BTA substrate was not sooted. The two left BSM aero heat shield covers had been bent by parachute entanglement; the lower right cover was locked in the fully open position, and the forward right cover was missing.

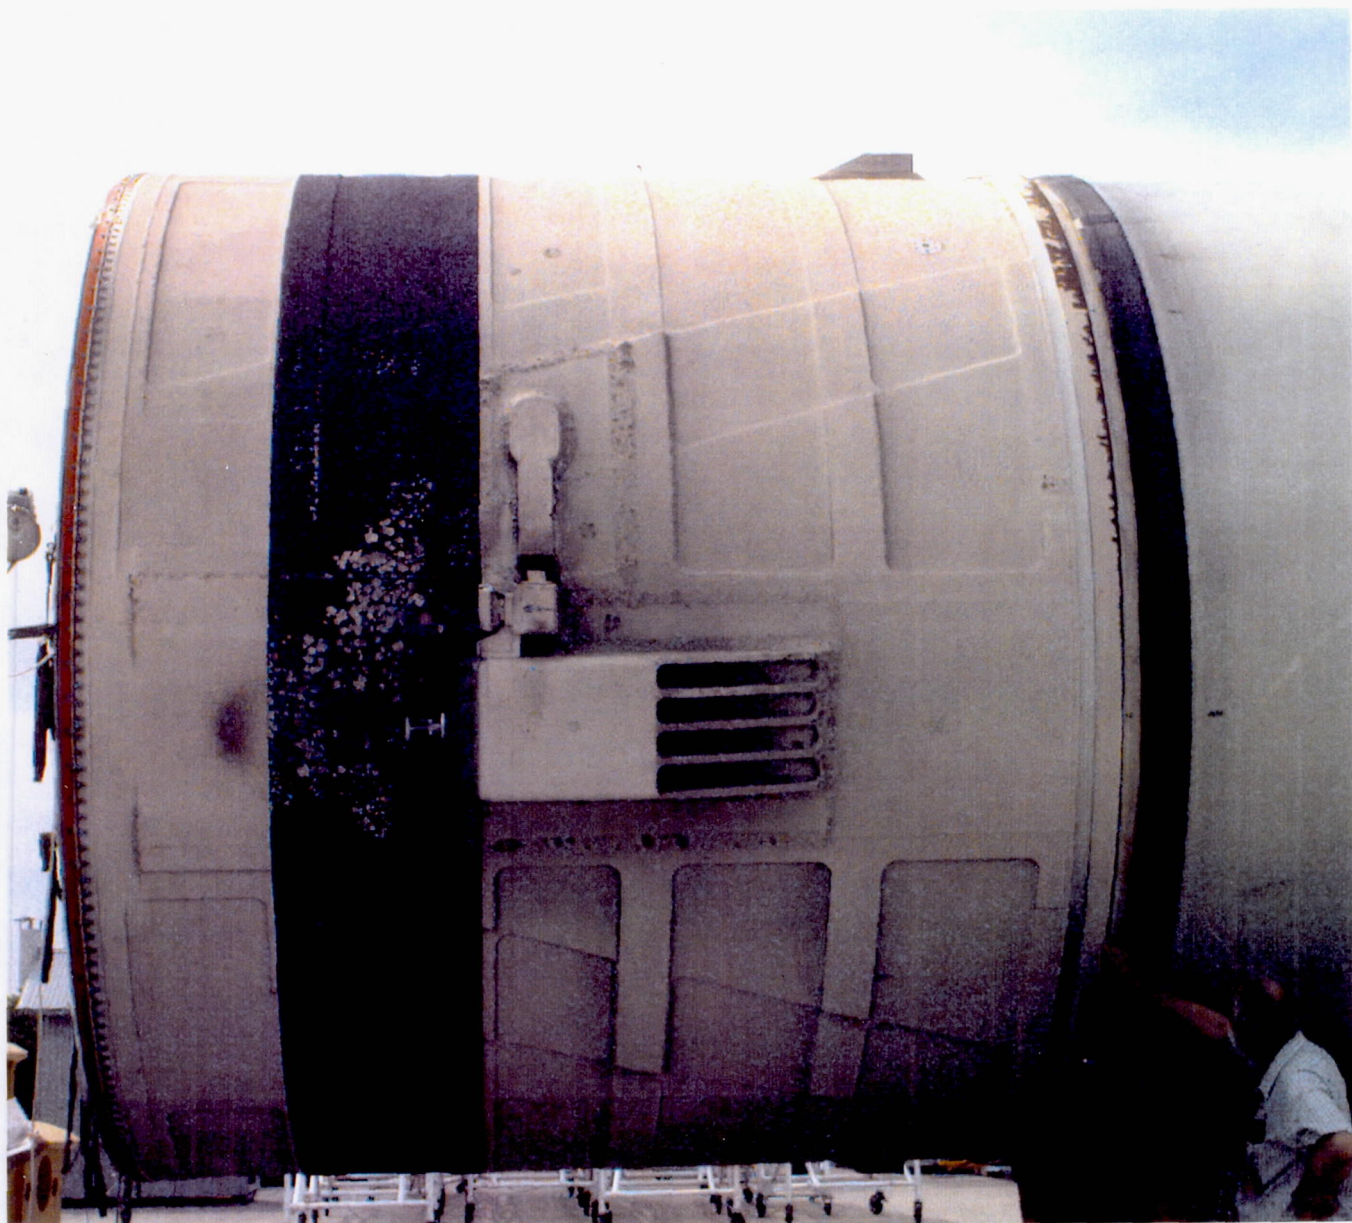
Photo 17: LH Forward Skirt

The LH forward skirt exhibited no TPS debonds. Both RSS antennae covers/phenolic base plates were intact though some of the phenolic layers had delaminated. Hypalon paint was blistered/missing over the areas where BTA closeouts had been applied. No pins or retainer clips from the frustum severance ring were missing or damaged.

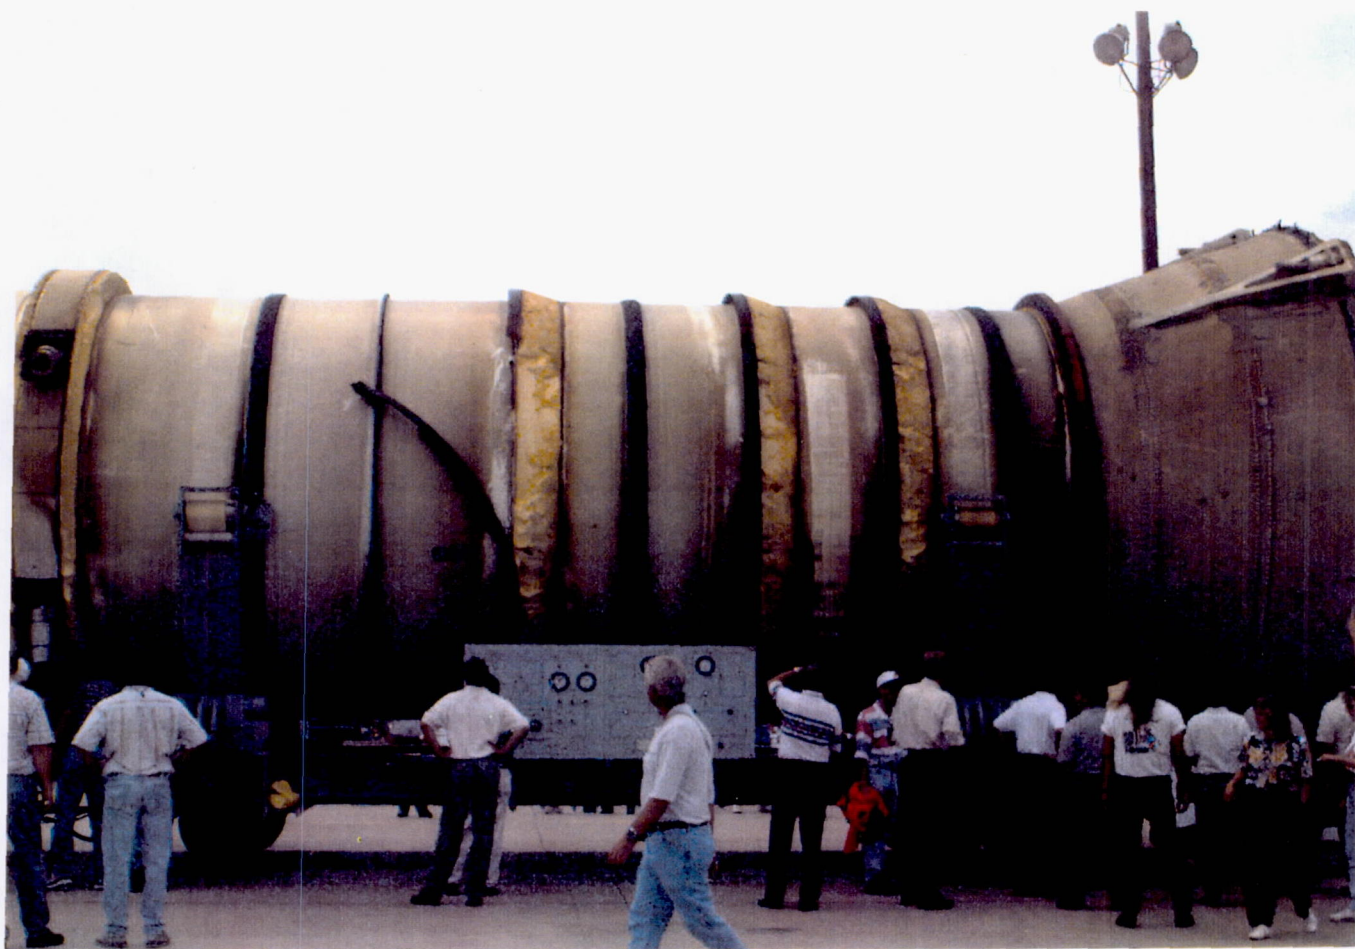
Photo 18: LH Aft Booster/ Aft Skirt

Several stiffener rings had been damaged by water impact. The forward stiffener ring had separated from the aft booster from 190 to 240 degrees.

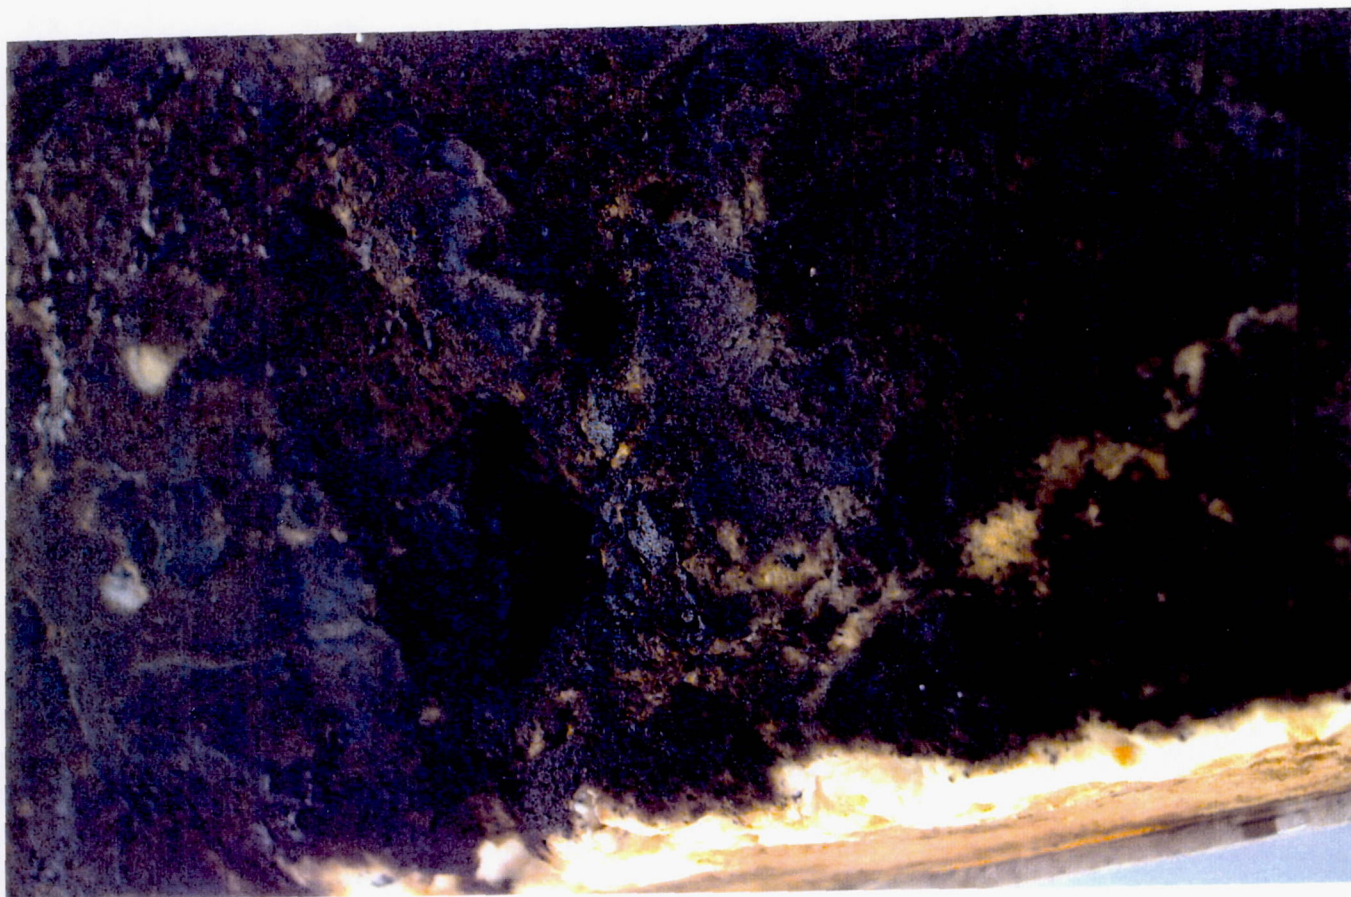
Photo 19: ETA Ring Debris Impacts

Four indentations, one of which is shown in the above photograph, in the forward face of the ETA ring were most likely caused by debris impacts. However, no foreign objects were visible in the indentations.

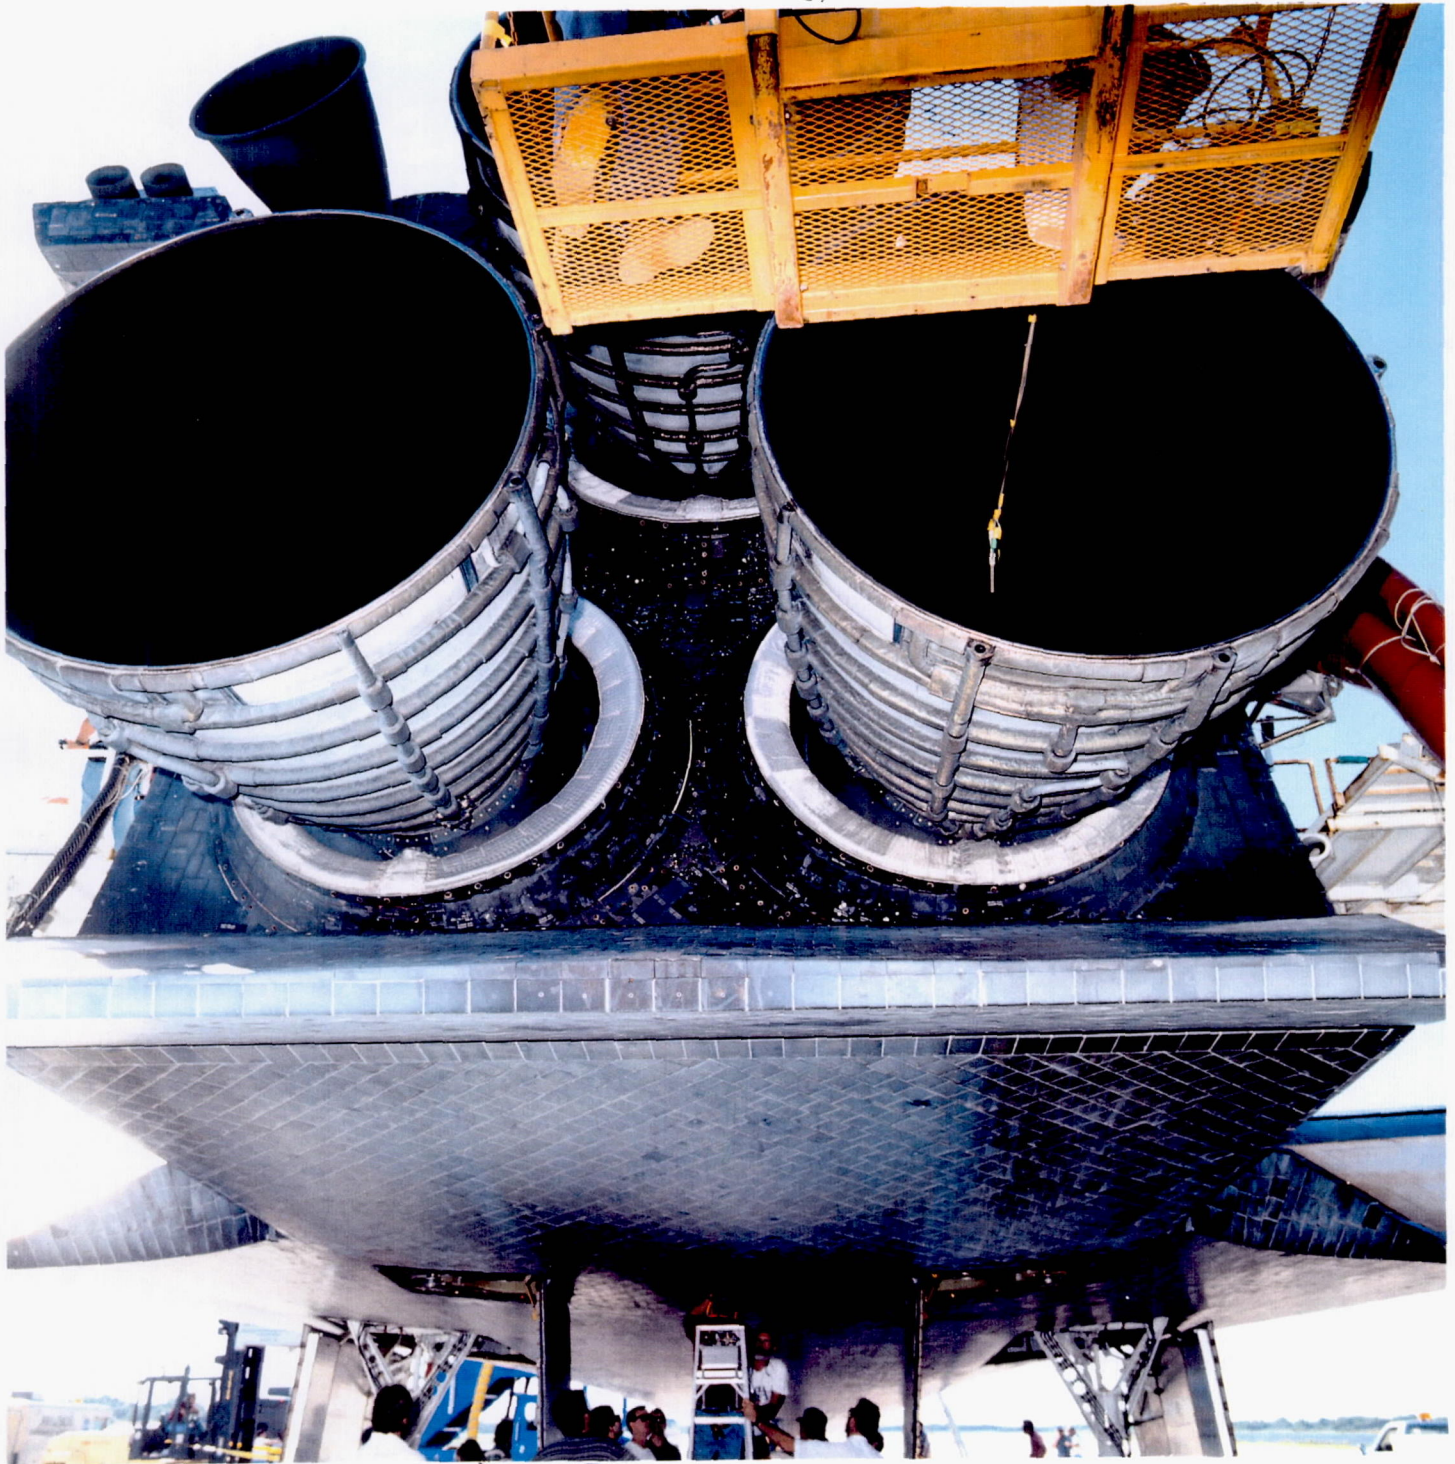
Photo 22: Base Heat Shield/SSME's

All three SSME Dome Mounted Heat Shield (DMHS) Blankets were in excellent condition.

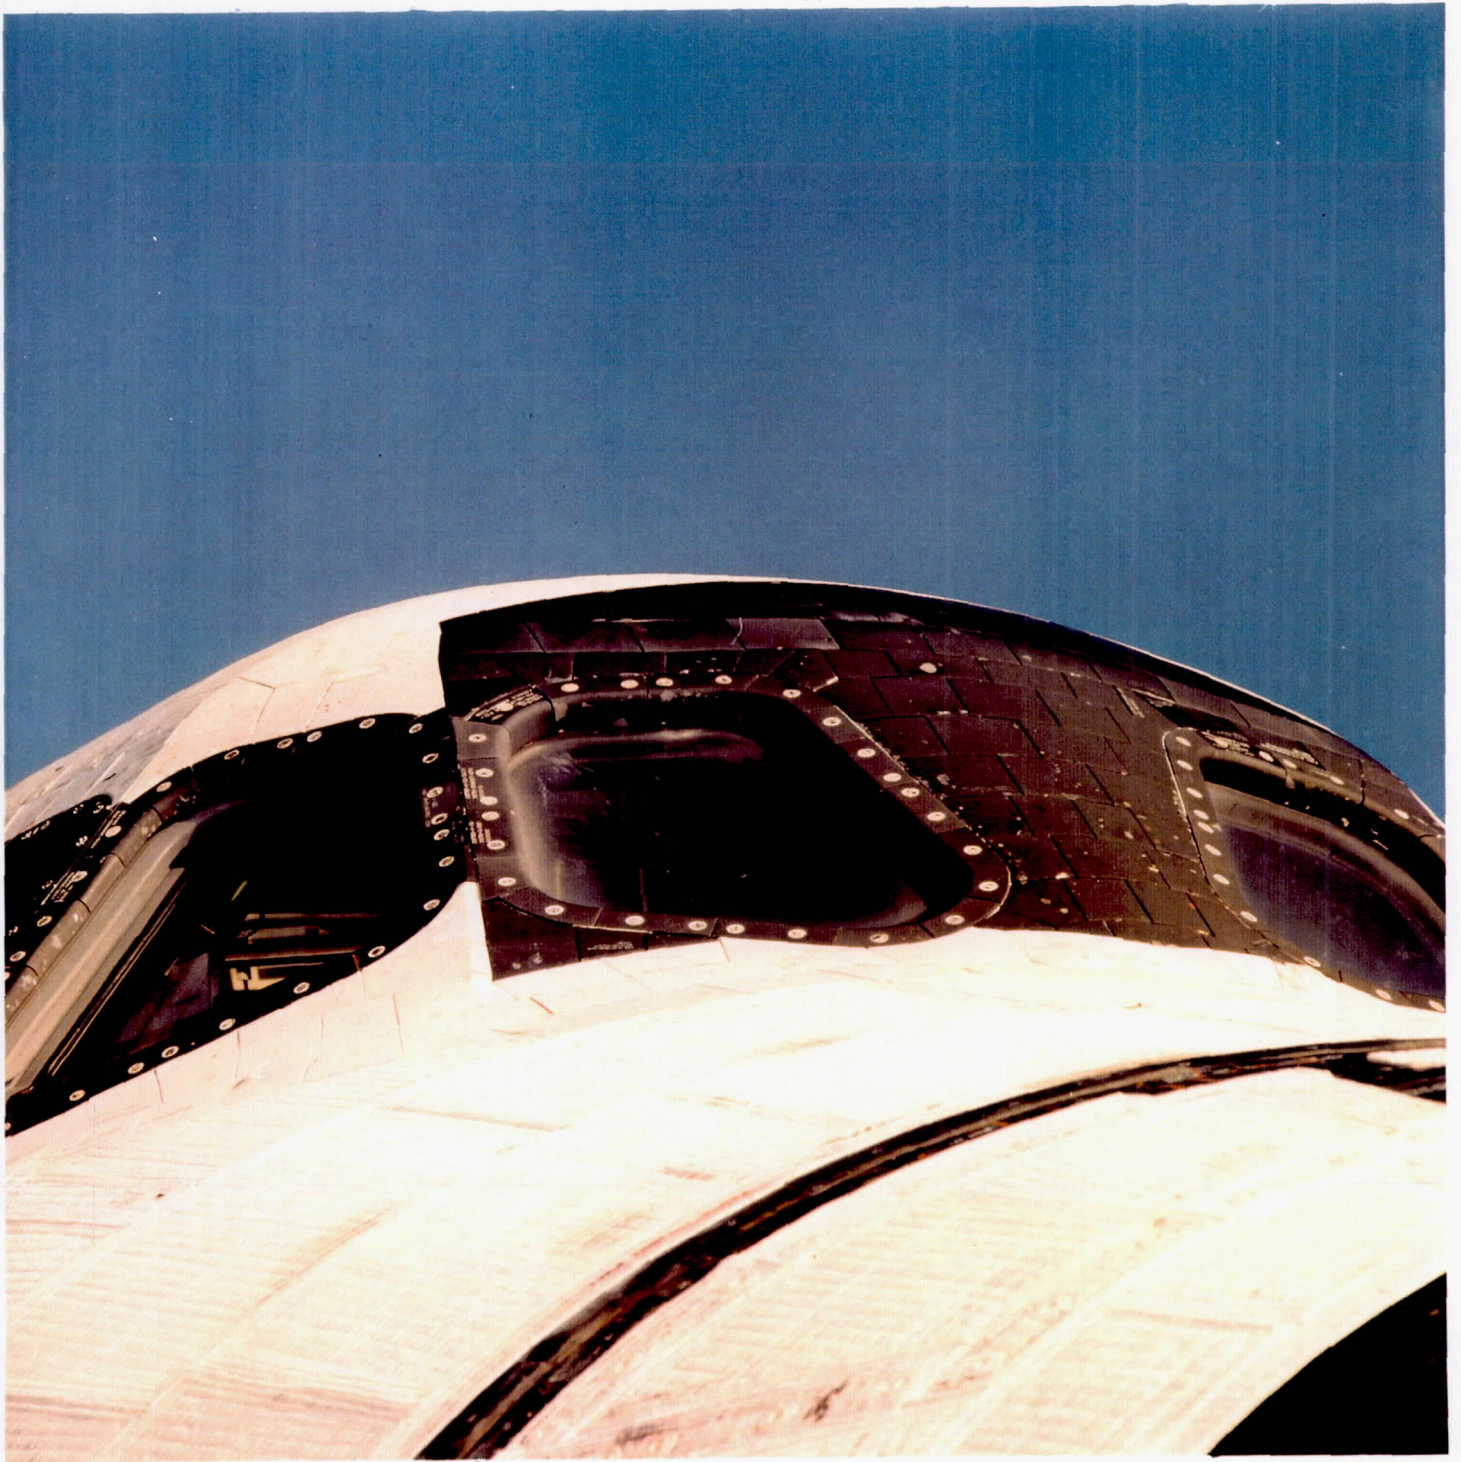
Photo 25: Orbiter Windows 4-6

Hazing and streaking of Orbiter windows #4 and #5 was typical. Window #4 had 2 splatter marks which were most likely caused by impacts from FRCS RTV.

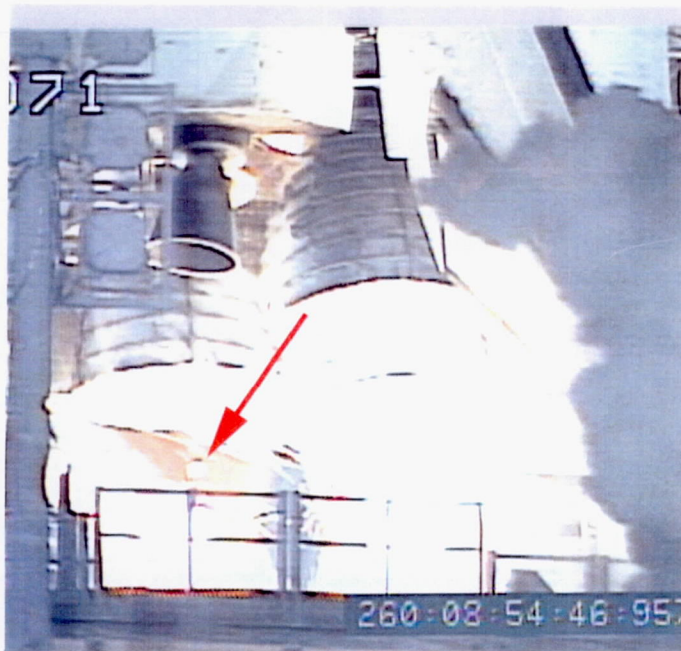
Figure 2.1.1.1 Debris Aft of the SSMEs During SSME Ignition

Several pieces of light-colored debris (probable RCS paper) were seen aft of the SSMEs during SSME ignition (08:54:45.623, 08:54:46.957 UTC).

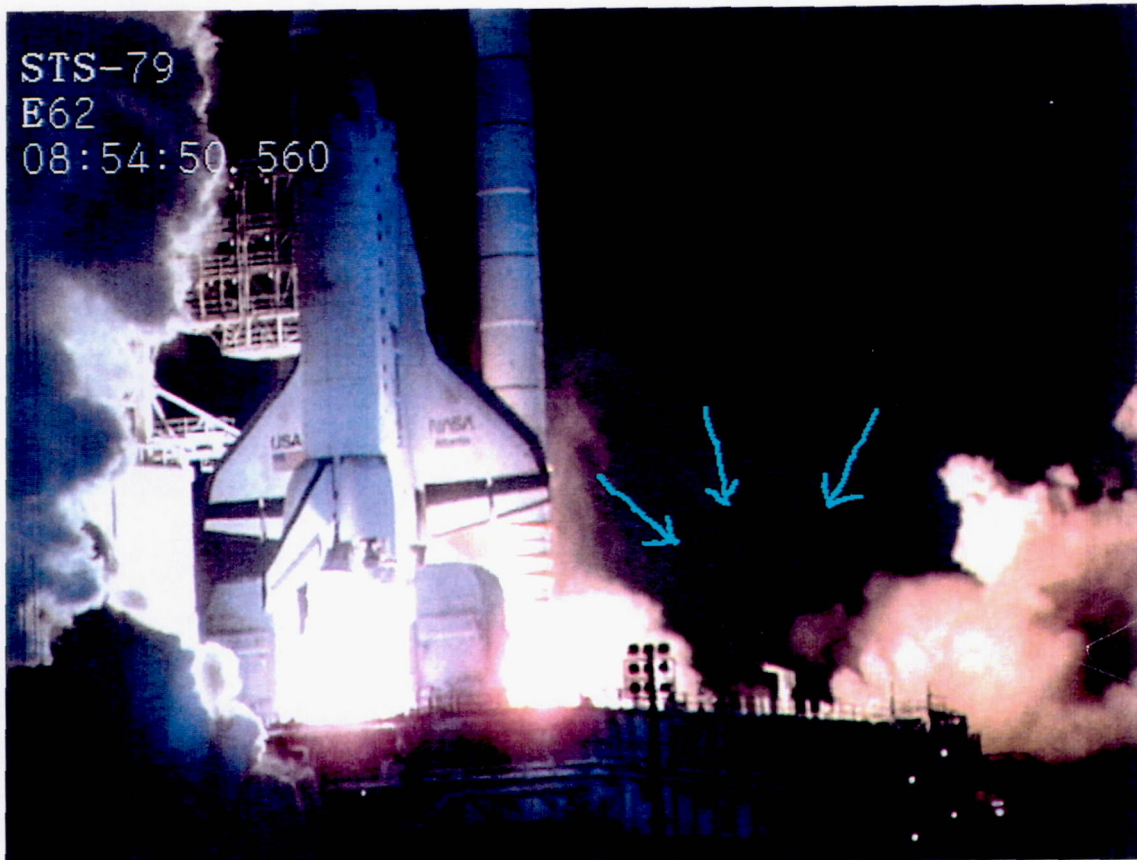
Figure 2.1.2.1 Debris Seen North of the Launch Vehicle at Liftoff

Multiple pieces of debris (at least eight) from the SRB flame trench area (possibly SRB throat plug material) were seen north of the launch vehicle at liftoff (08:54:50.560 UTC). Debris north of the launch vehicle at liftoff has been seen on previous missions.

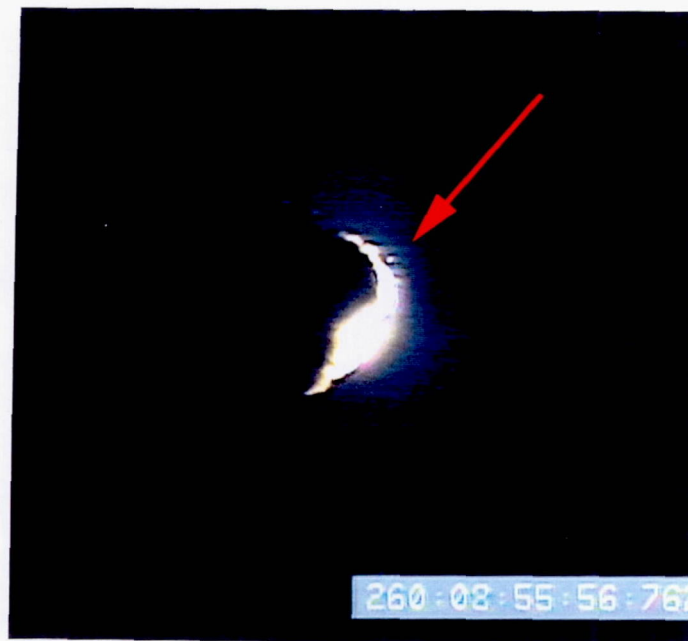
Figure 2.1.3.3 Debris Falls Along SRB Plumes

Multiple pieces of debris (at least nine), possible SRB aft skirt instafoam, were seen falling aft along the SRB exhaust plume during ascent (08:55:54.927 UTC to 08:56:15.281 UTC). A single piece of debris was seen falling aft along the SRB exhaust plume at 08:56:49.7 UTC. Debris aft of the launch vehicle during ascent has been seen on previous missions.

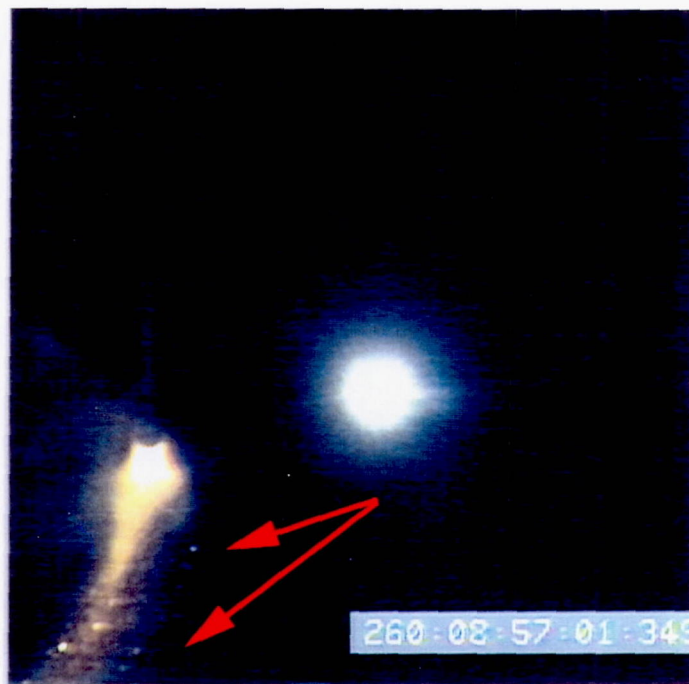
Figure 2.1.3.4 Slag Debris Seen Exiting the SRB Exhaust Plumes

Multiple pieces of slag debris were seen falling from the SRB exhaust plumes and SRB nozzles before, during, and after SRB separation. Slag debris at SRB separation has been seen on previous missions, particularly on nighttime views.

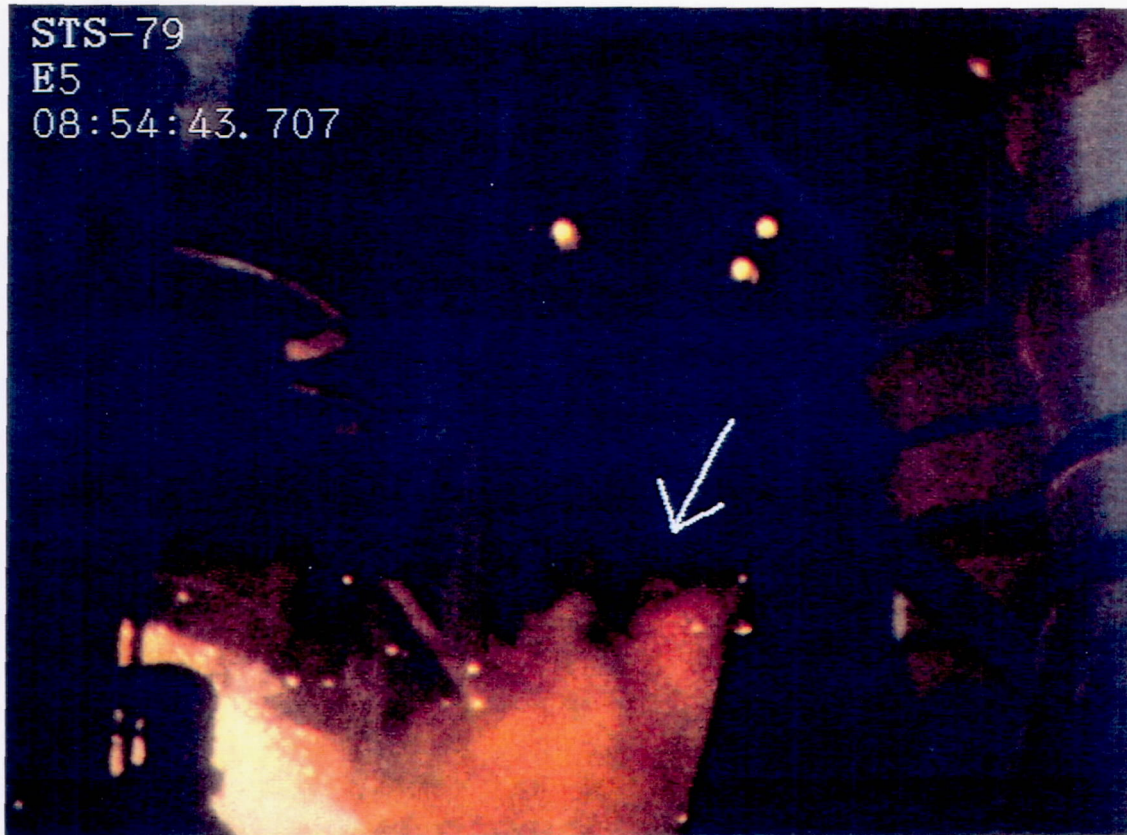
Figure 2.2.2 Orange Vapor Seen During SSME Ignition

Orange vapors, probably free burning hydrogen, were seen above the SSME rims, near the body flap, and near the base of the vertical stabilizer during SSME ignition (08:54:43.7 UTC). Orange vapors have been seen on previous missions. Camera E5 provides a good view of what appears to be a significant amount of orange vapor near the body flap during engine start-up. No follow-up action was requested.

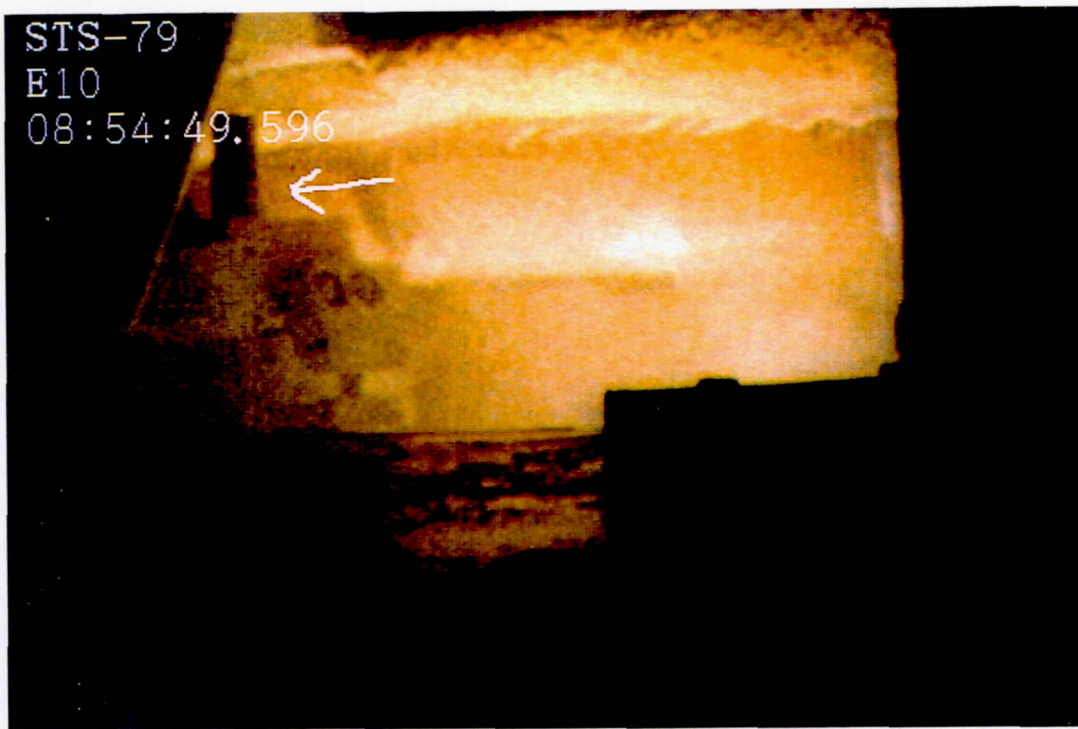
Figure 2.2.7 Bolt Hang-Up at Holddown Post M-3

A bolt hang-up was seen at the RSRB holddown post M-3 at liftoff (08:54:49.594 UTC). No debris fragments were seen near the DCS during the hang-up and bolt release. SRB holddown bolt hang-ups have been seen on five of the last seven previous missions. See Table 2.2.7. No follow-up action was requested.

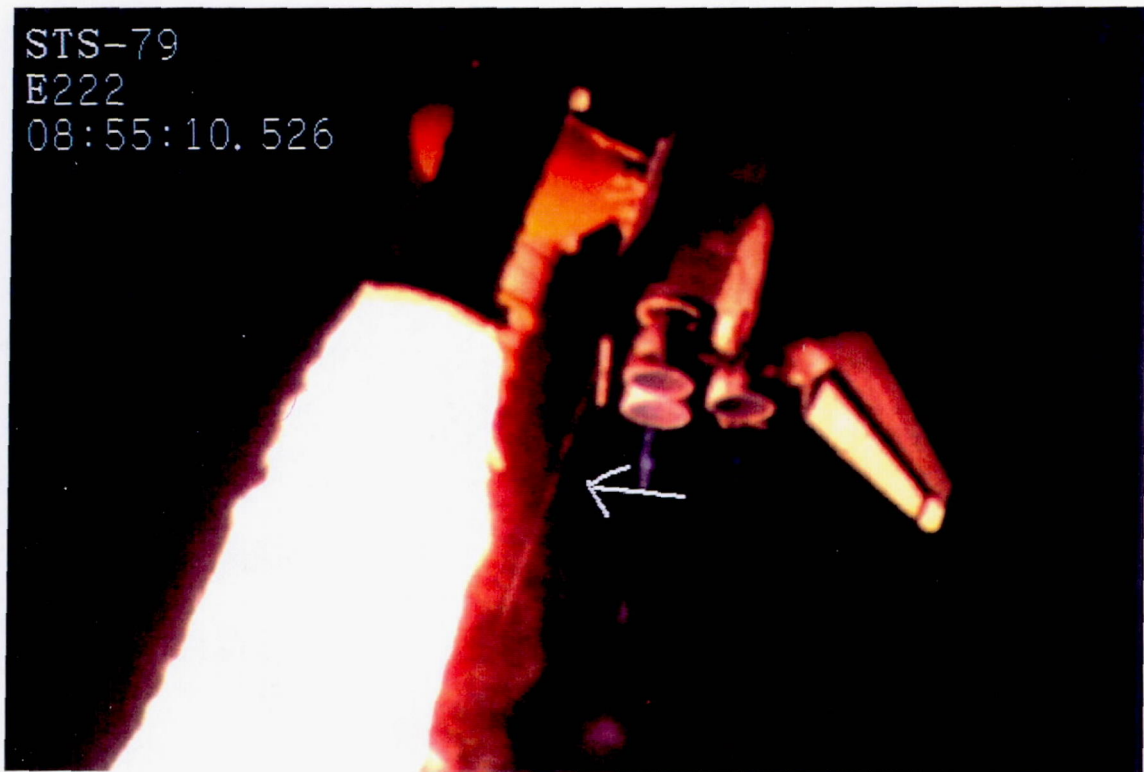
Figure 2.3.2 Contrail Seen During Ascent

A faint white (intermittent) streak first seen near the center of the right outboard elevator trailed aft of the right wing between 08:55:10.021 and 08:55:10.9 UTC. This is probably the same white streak that appeared near the body flap on camera view E222 between 08:55:09.8 and 08:55:10.8. On camera E57, a contrail was seen originating from the left wing tip at 08:55:06.846 UTC. The white streak was probably a contrail of visible moisture. No follow-up action was requested.

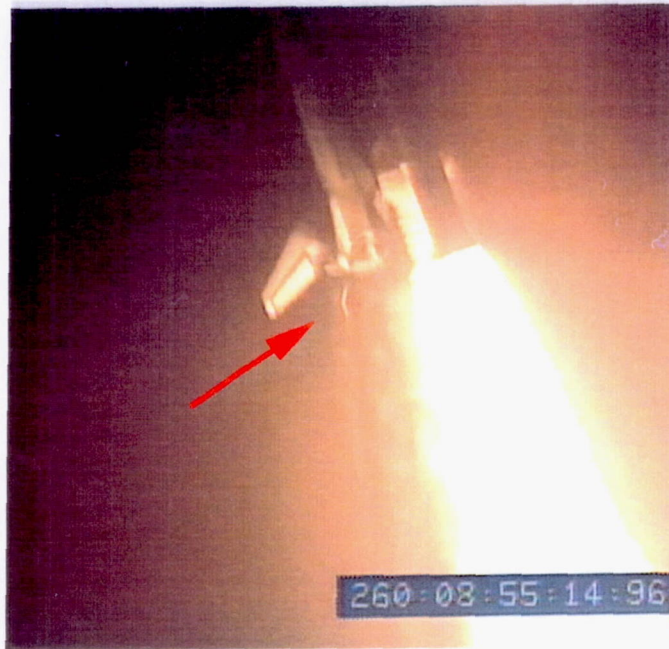
Figure 2.3.3 Flare in SSME Exhaust Plume

Two orange-colored flares, probably debris induced, were seen in the SSME exhaust plume after the roll maneuver (08:55:14.963, 08:55:14.981 UTC). Flares in the SSME exhaust plumes have been seen on previous missions. No follow-up action was requested.

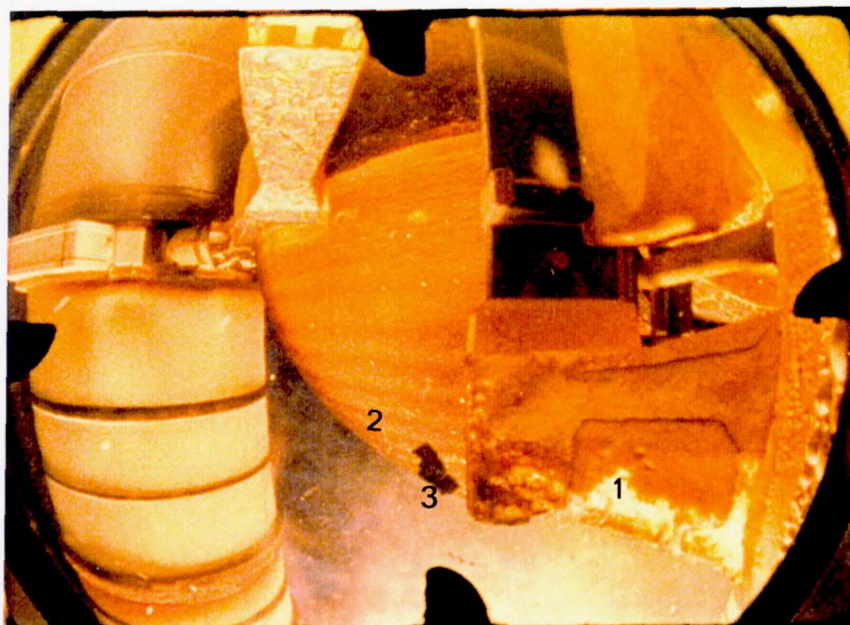
Figure 2.4.1 LSRB/ET Aft Dome

TPS ablation was noted on the LH2 electric cable tray (1). Ablation to the ET aft dome TPS was seen (2). A piece of dark-colored debris (probably charred TPS material) was seen near the LH2 electrical tray (3). Blistering of the LH2 ET/Orbiter umbilical fire barrier coating was typical.

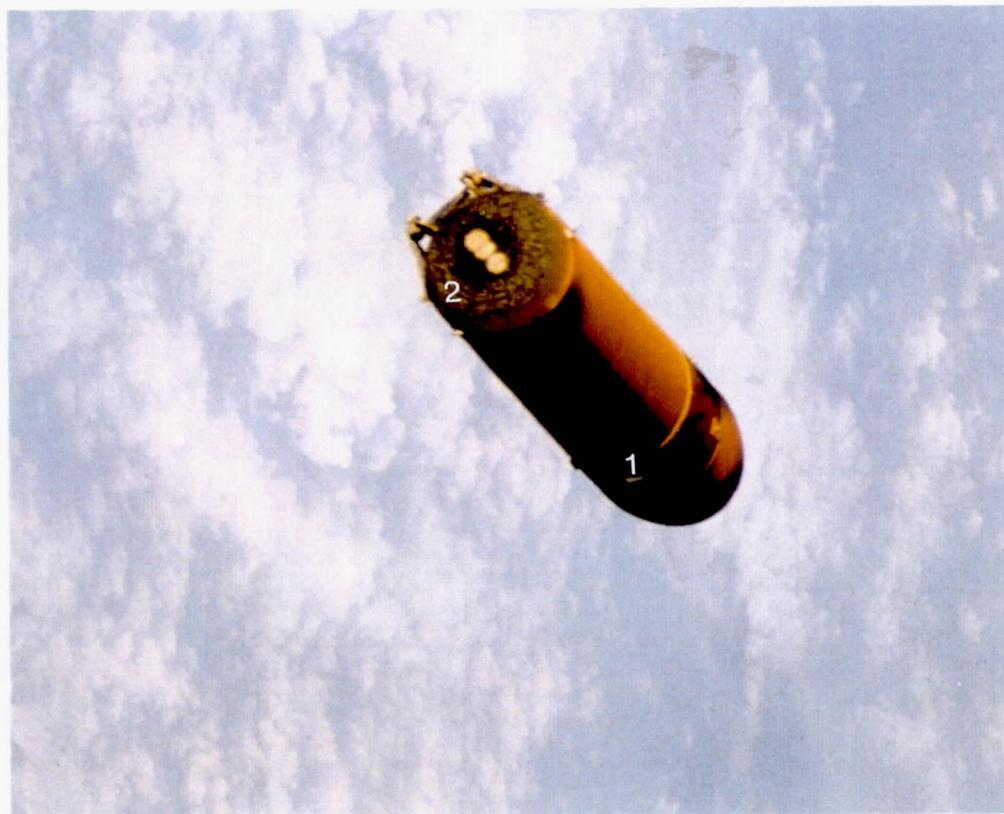
Figure 2.4.2 (A) Handheld View of the External Tank

STS-79 was the first flight of the dark composite intertank access door (which replaces the previously used foam-covered door). The new composite intertank access door appears in good condition in the handheld camera view above (1).

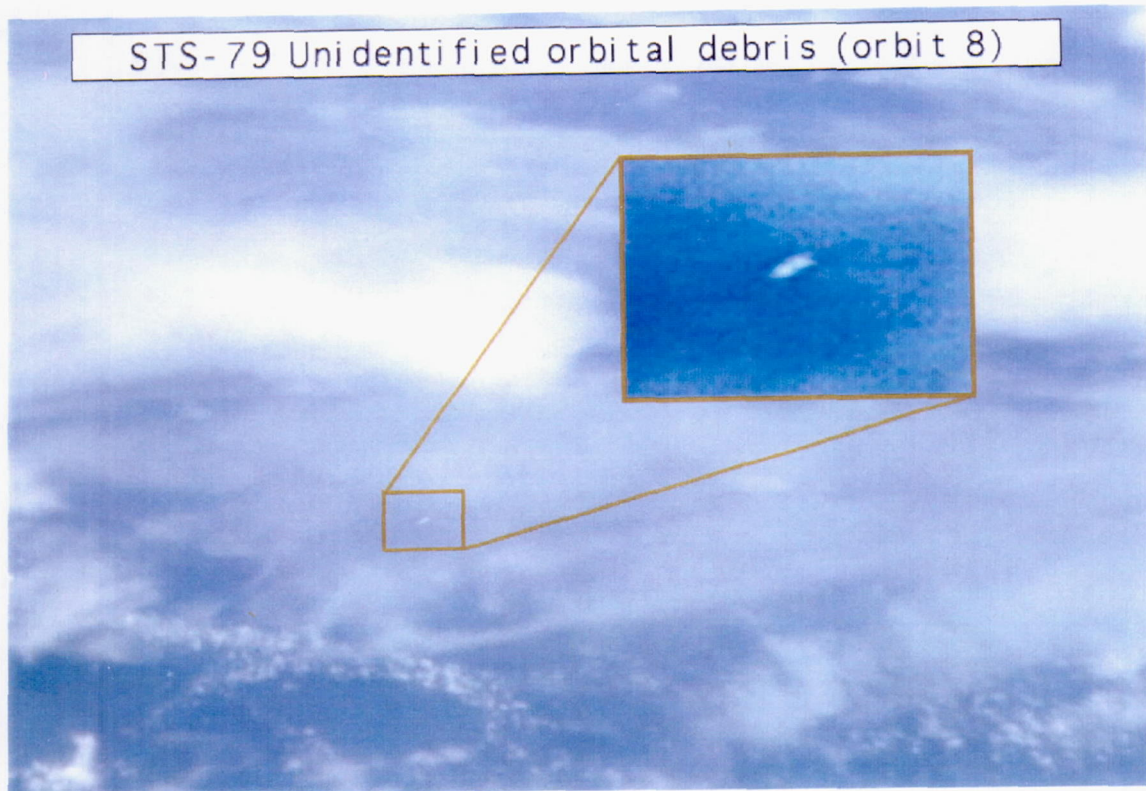
Figure 2.5.1 Debris Seen on Orbit 8

Analysis of a five minute segment of STS-79 downlink taken 11 hours after launch (260:19:58 UTC), revealed a bright-colored piece of debris moving in proximity to the Orbiter at a lower altitude and a slightly different inclination. The debris appeared uniformly white in color, oblong in shape ($L/D = 3$), and was gyrating freely with a period of approximately 0.7 seconds. Attempts to determine the size of the debris were inconclusive.

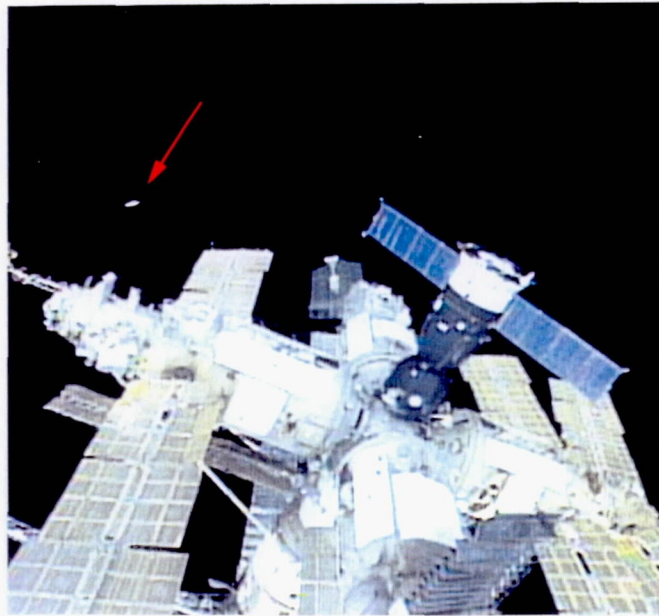
Figure 2.5.2 Debris Seen from Payload Bay Camera after Mir Docking

A reflective-appearing piece of debris was seen from Orbiter payload bay camera B after docking to the Mir space station. The debris did not appear to contact the Orbiter or the Mir Space Station. No follow-up action was requested.
